HYDROGEN CRACKING DURING SERVICE OF HIGH STRENGTH STEEL CANNON COMPONENTS

SEPTEMBER 1997

6. AUTHOR(S) J.H. Underwood, E. Troiano, G.N. Vigilante, A.A. Kapusta, and S. Tauscher					
7. PERFORMING ORGANIZATION NAME(S) AND ADDRESS(ES) U.S. Army ARDEC Benet Laboratories, AMSTA-AR-CCB-O Watervliet, NY 12189-4050				8. PERFORMING ORGANIZATION REPORT NUMBER ARCCB-TR-97021

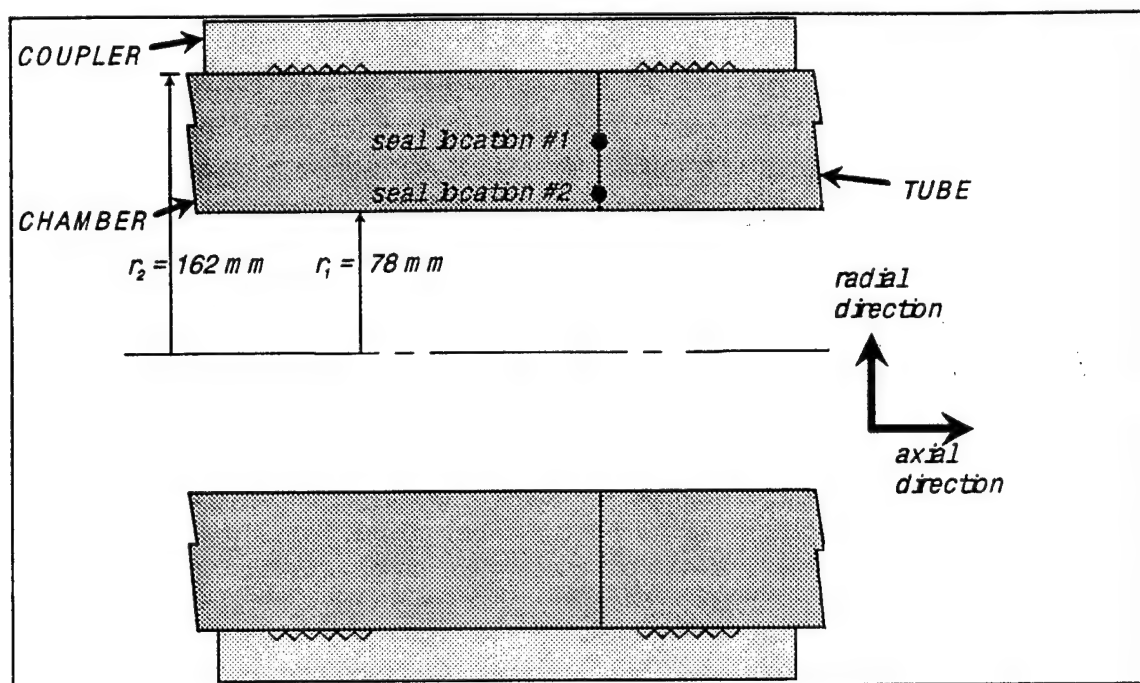
FIG. 1 - Sketch of Cannon Configuration and Nomenclature

The general configuration of the cannon components that sustained rapid cracking is shown in Figure 1. Cannon chamber and tube sections are connected using a cylindrical coupler with segmented threads on its inner surface. As the coupler draws the chamber and tube together, a preload is applied to the pressure seal between the two sections. Two seal locations that have experienced separate occurrences of rapid cracking are described here. Seal location #1, shown in Figure 2, is at a position about midway through the 84-mm wall thickness of chamber and tube. A triangular-shaped copper beryllium seal was used, along with a vented guard ring that allowed pressure on the seal while preventing a direct flow of cannon propellant combustion products onto the seal.

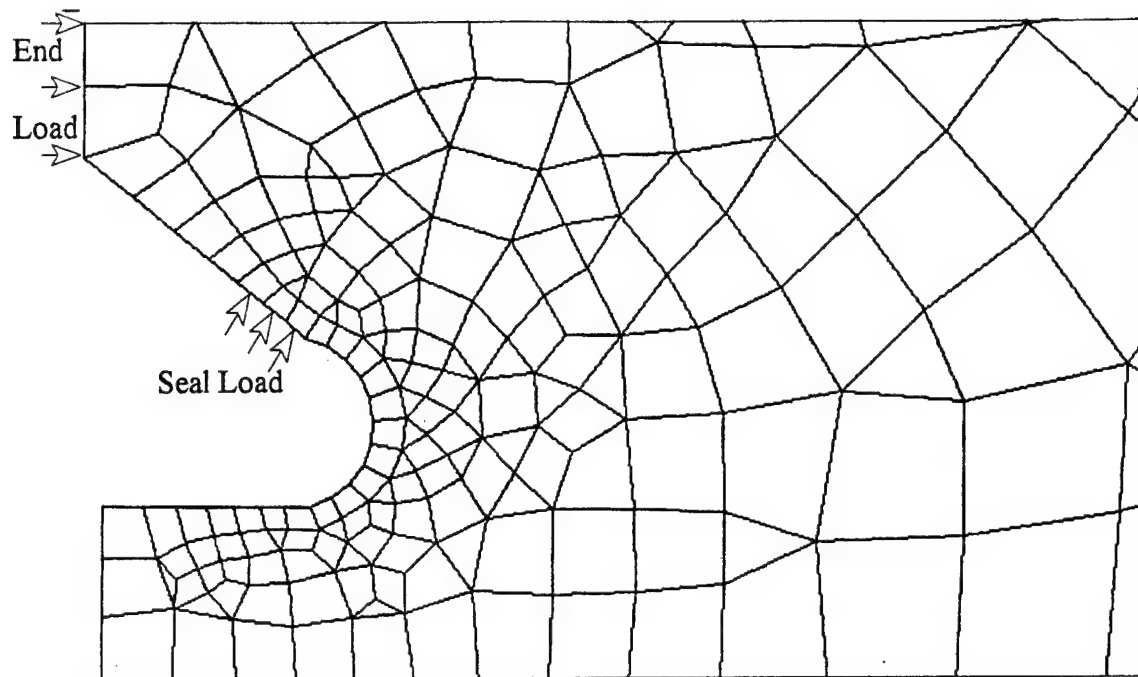
FIG. 7 - Finite Element Grid for Analysis of Cracking at Location #2

The important unanswered question at this point of the fracture case study was whether or not a significant sustained tensile stress could be accounted for at the location #2 failure location. A finite element analysis was performed to answer this question, using the ALGOR program. The portion of the grid in the area of the seal pocket is shown in Figure 7. The two types of sustained loads discussed previously were considered in the analysis and are shown schematically in Figure 7. The end load is caused by the contact between the chamber and tube sections of the cannon as they are drawn together by the coupler, see again Figure 1. An average end load of 156 MPa was determined from prior work (ref 2), based on typical loads on the coupler threads. The seal load, the other type of loading considered, was determined from the yield and ultimate strengths of the seal material given earlier and the significant values of triaxial stresses that are present in contact stress situations. Based on prior work (ref 7), the contact stresses are 2.97 times larger than the uniaxial yield strength of the material, the lower strength seal material in this case. Using this value of 2.97 and the average of the yield and ultimate strengths of the seal material, 1019 MPa, gives a seal load of 3023 MPa.
